**Subject:** Technical Memorandum: Second Year Assessment of Block F trees near GWETS trenching  
Lockheed Martin Corporation – Middle River Complex  
2323 Eastern Boulevard, Middle River, Baltimore County, Maryland

## TECHNICAL MEMORANDUM

<b>To:</b>	Tom Blackman, Cannon Silver, Katie Young
<b>From:</b>	Michael Martin, Jeff White
<b>Cc:</b>	
<b>Date:</b>	October 7, 2022
<b>Subject:</b>	Second year assessment of Block F trees near GWETS trenching
<b>Attachments</b>	none

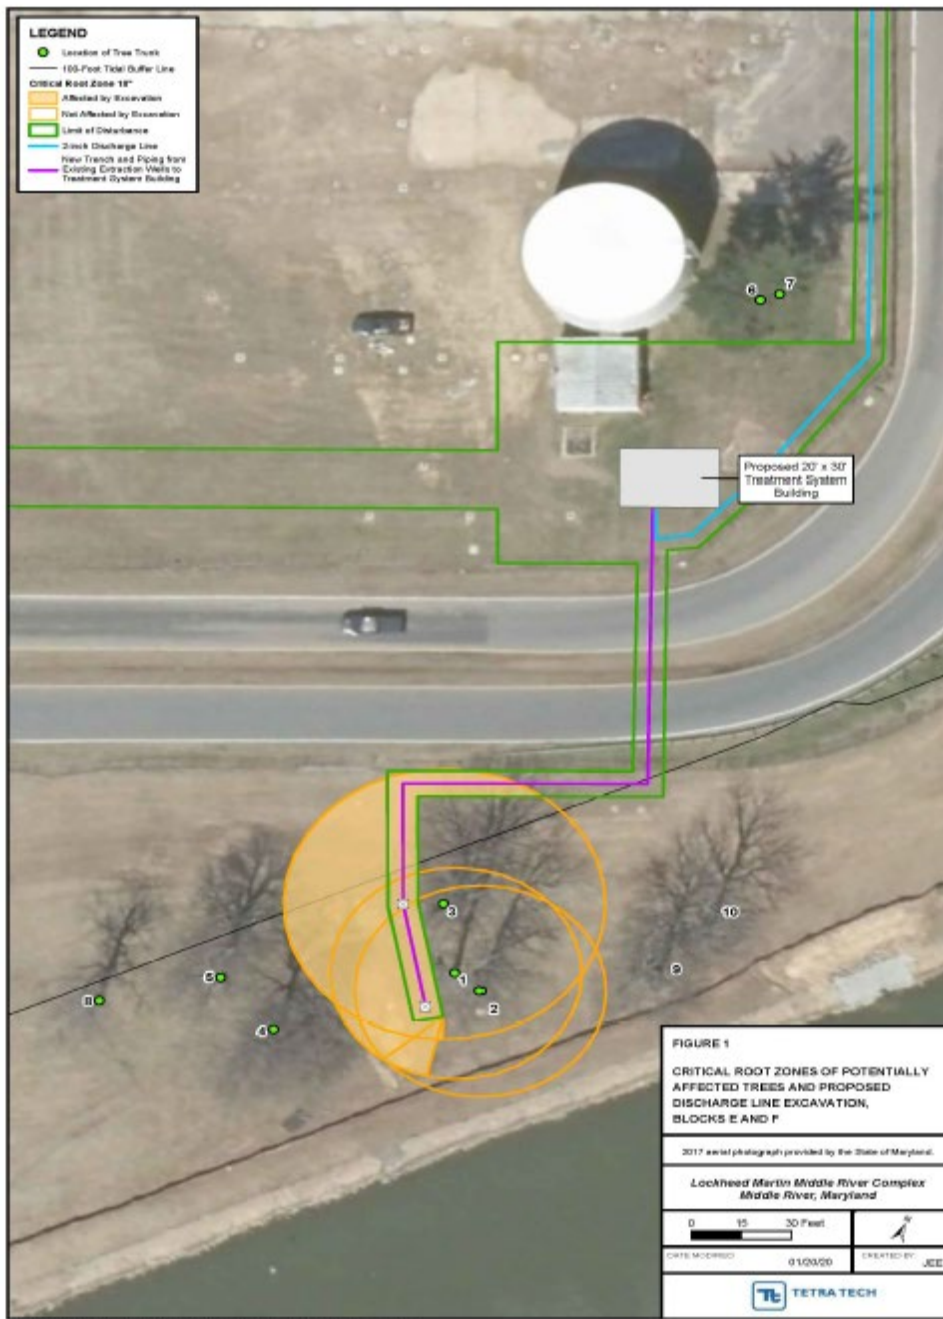
In July 2020, a 3-ft deep trench was excavated through the critical roots zone of the three mature white oak trees with precautions taken as described in the referenced BCDEPS submittal. The oaks vary slightly in distance from the trench as shown in Figure 1. The degree of

potential impact to the trees critical root zone is also depicted in Figure 1. During the first annual field assessment (July 29, 2021), the condition of the trees was assessed for any dieback, loss of leaves, discoloration of leaves, and insect or plant disease damage (Table 1). During the second annual field assessment (July 6, 2022), the condition of the trees was assessed for the same parameters (Table 2).

Figure 1– Location of trees in relation to proposed underground water discharge pipe.

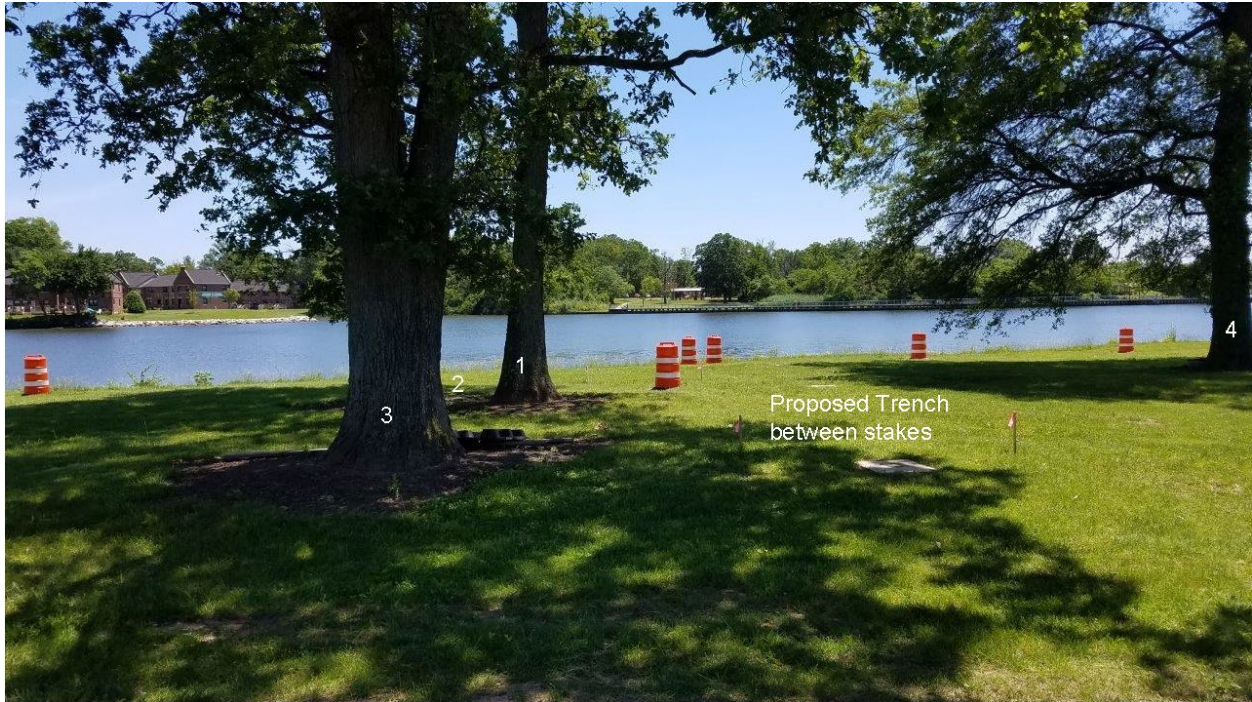
Photo 1– Ground view of the trees during baseline assessment; tree #1, tree #2, and tree #3 are white oaks (May 2020)

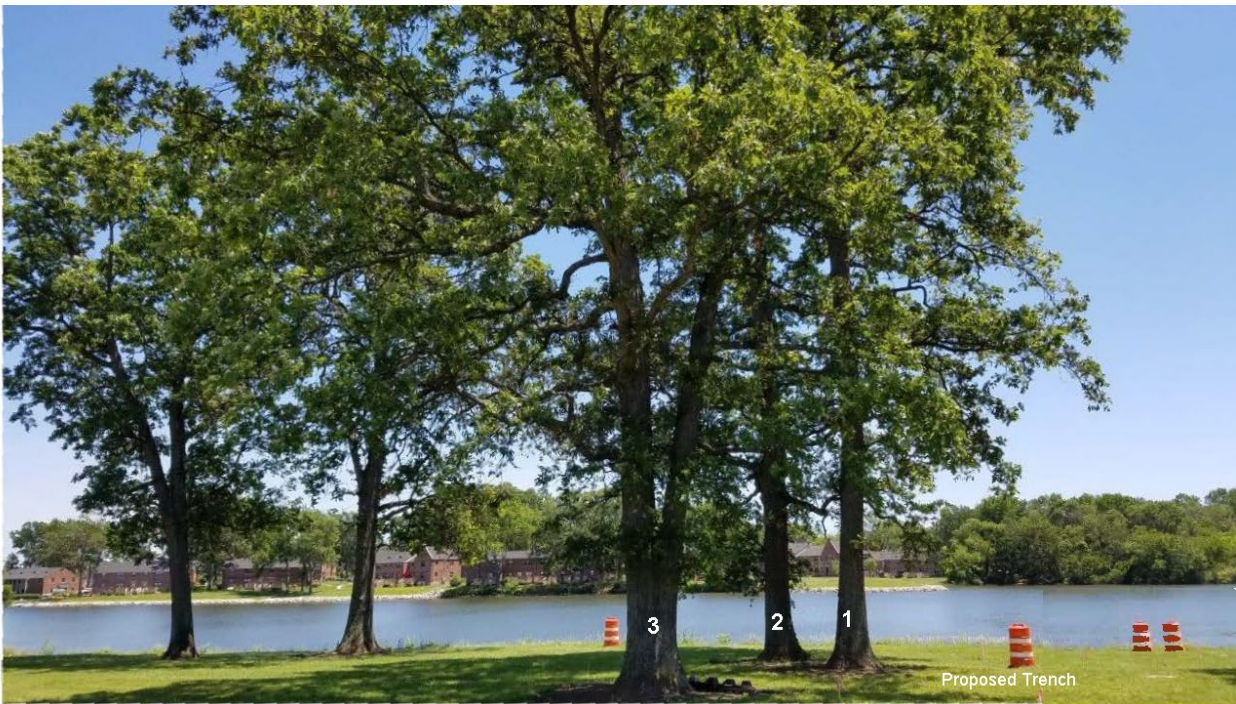
Photo 2 – Tree #1 is closest to the trench, followed by tree #2, and tree #3 (May 2020)

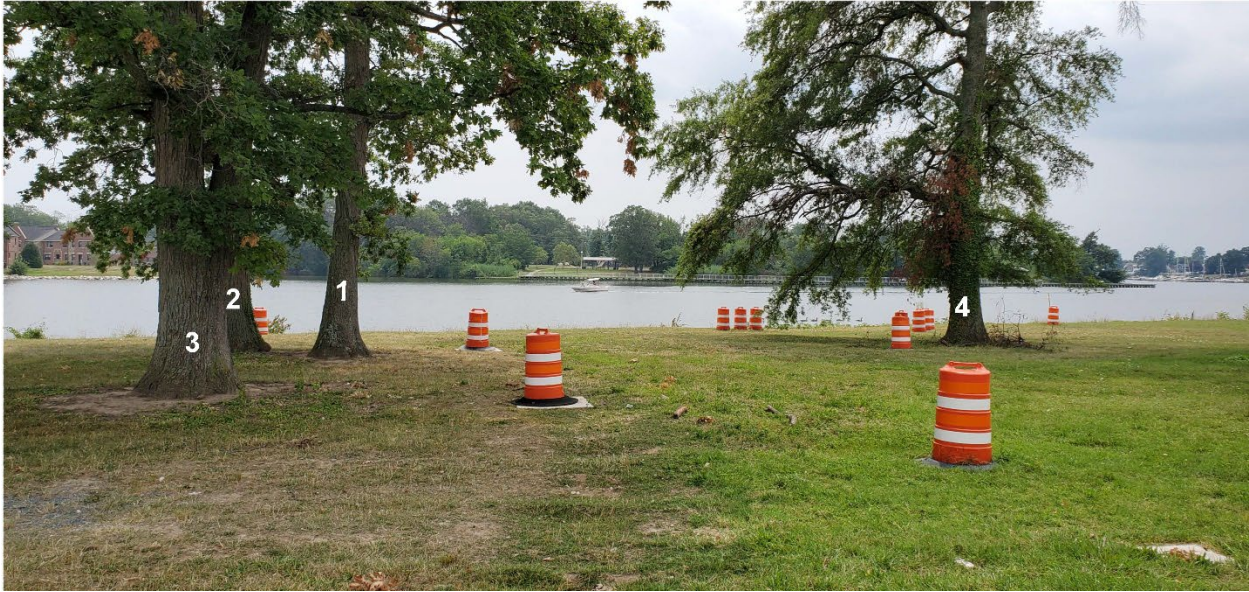
Photos 1 – 6 were taken during the July 29, 2021, inspection are included for comparison. In 2021 all three of the white oaks appeared healthy for their size and age (Photos 1 - 3). The canopy and crowns of all trees look acceptable for mature trees (Photos 4 - 6). Last year, (2021) was the year of the Brood X 17-year locust and their egg laying on the oaks resulted in the ends of some small branches dying (Photo 5).

*Photo 3, First year assessment (July 2021) site view; all three trees appear healthy.*

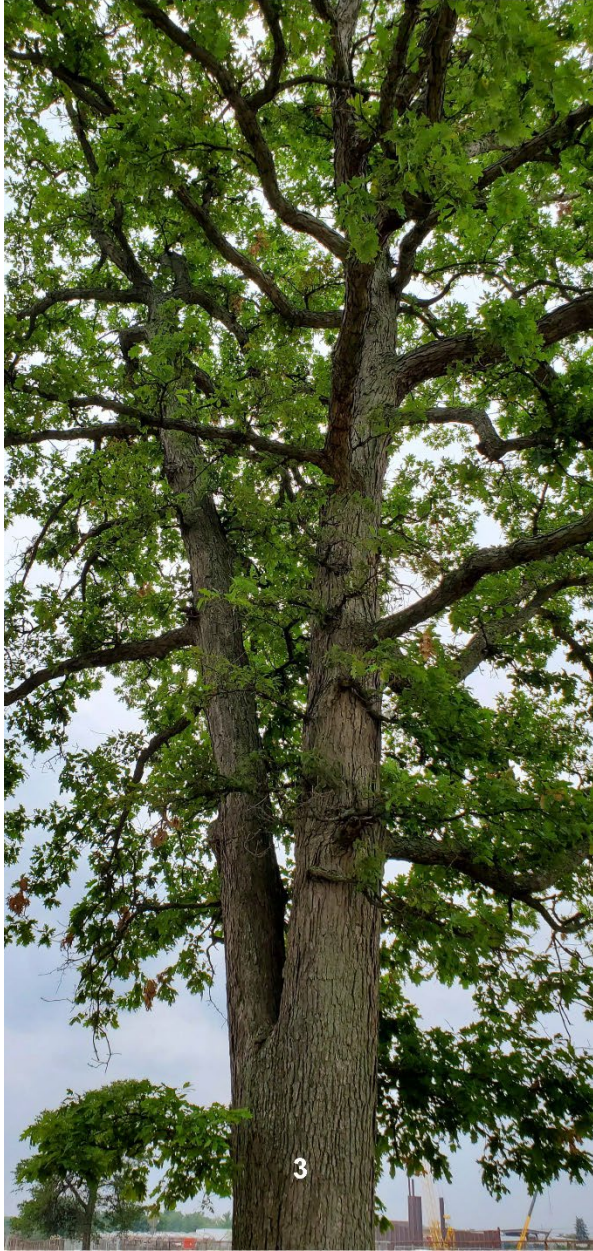
*Photo 4 – White oak with bifurcated (forked) trunk; tree appears healthy (July 2021).*

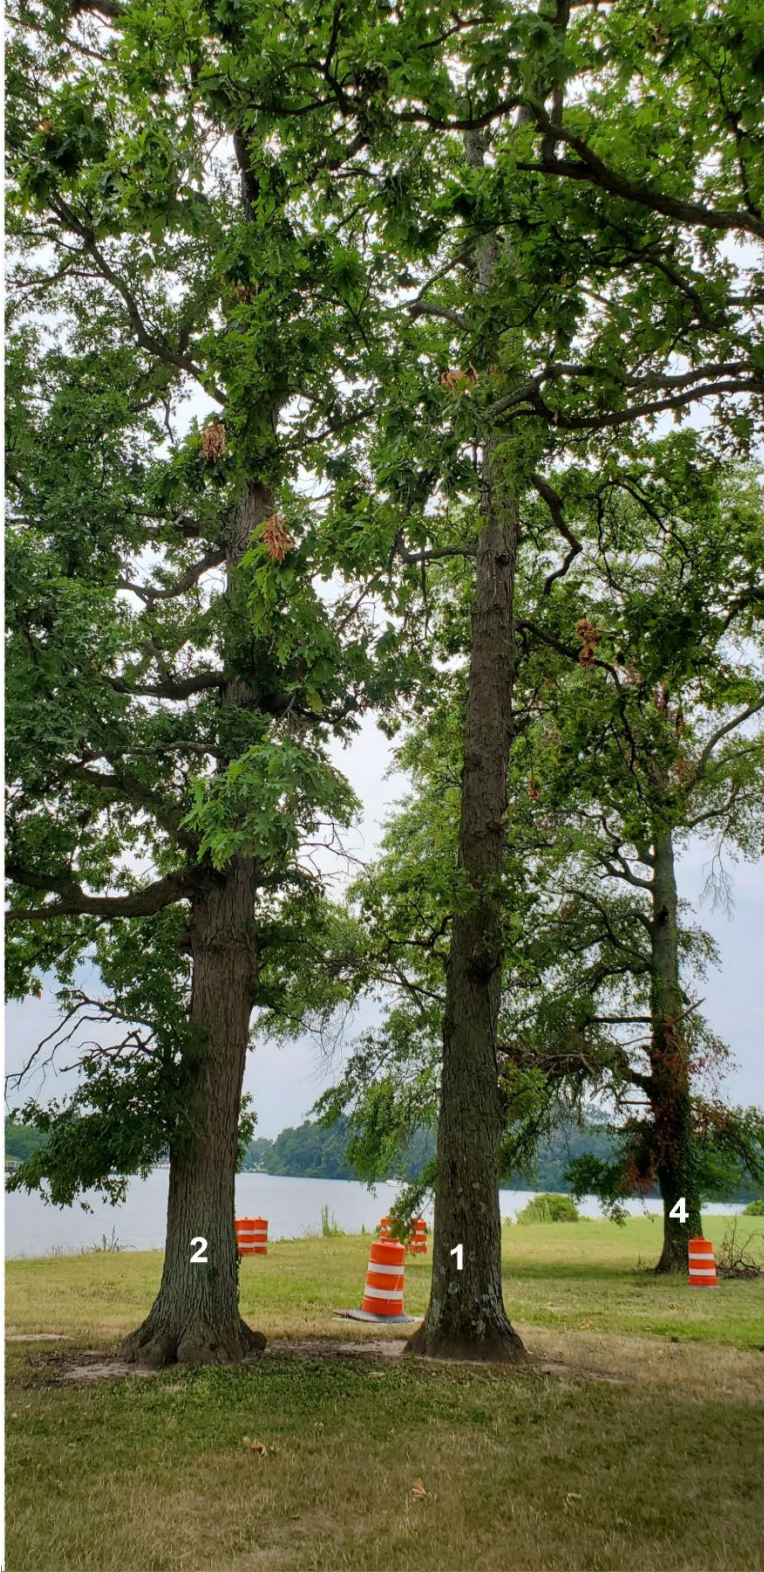
*Photo 5 – First year assessment (July 2021), looking southeast, pipe is buried between tree #1 and tree #4, and is closest to tree #1. Trees appear healthy. Brown (dead) branch trips are due to 17-year Cicadas and should not affect the health of the tree.*

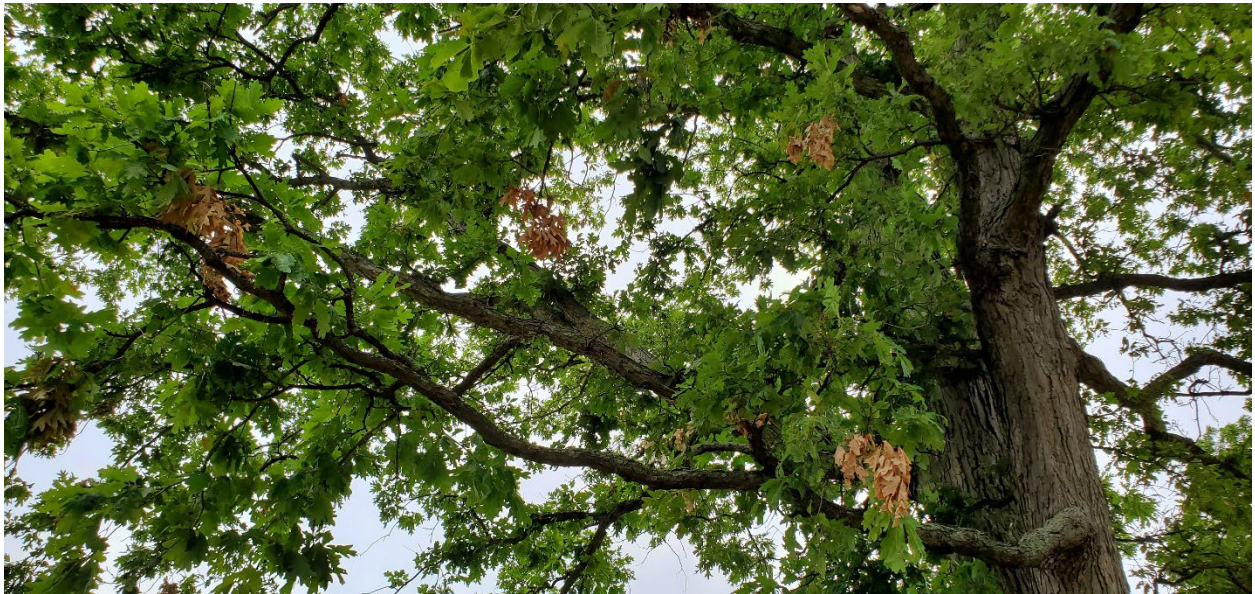
*Photo 6 – Canopy appears healthy on all three white oaks. (July 2021).*

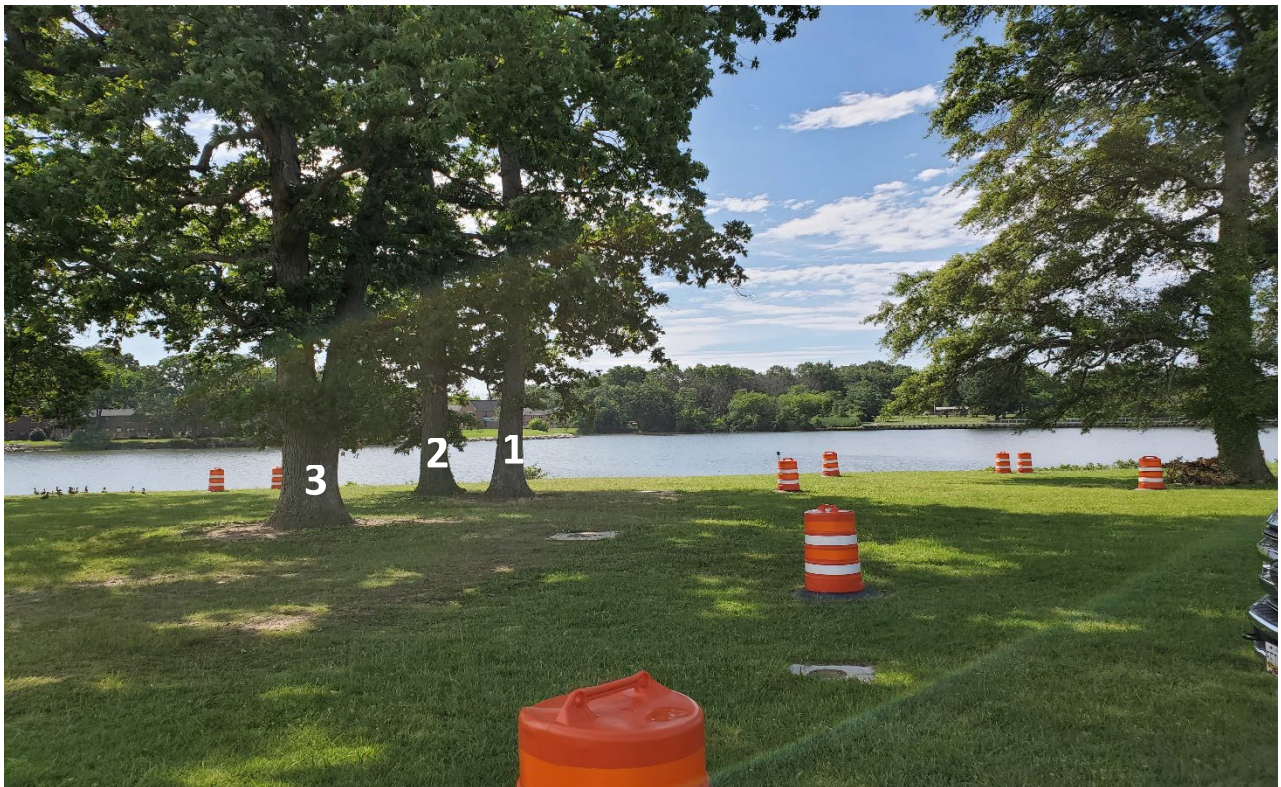
*Photo 7 Tree #1 is closest to the trench, followed by tree #2, and tree #3 (July 2022) Trench runs between tree 1, 2, 3 and closest line of barrels (July 2022).*

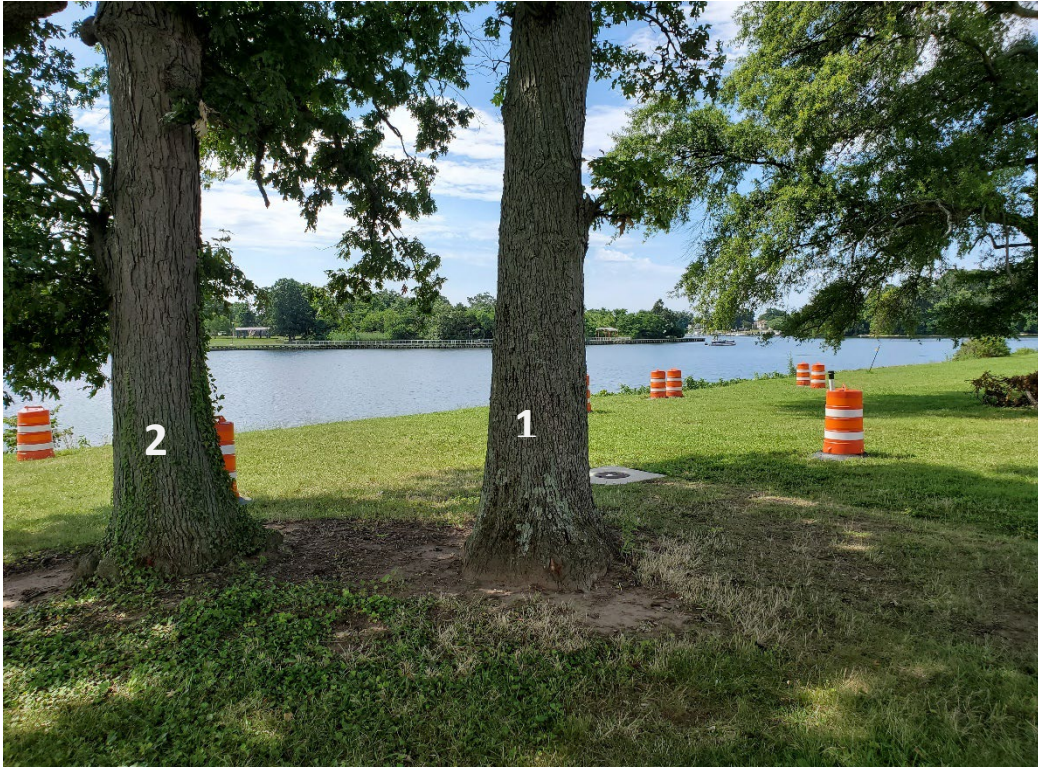
*Photo 8 View of tree 1 and 2 looking south along Dark Head Cove (July 2022)*

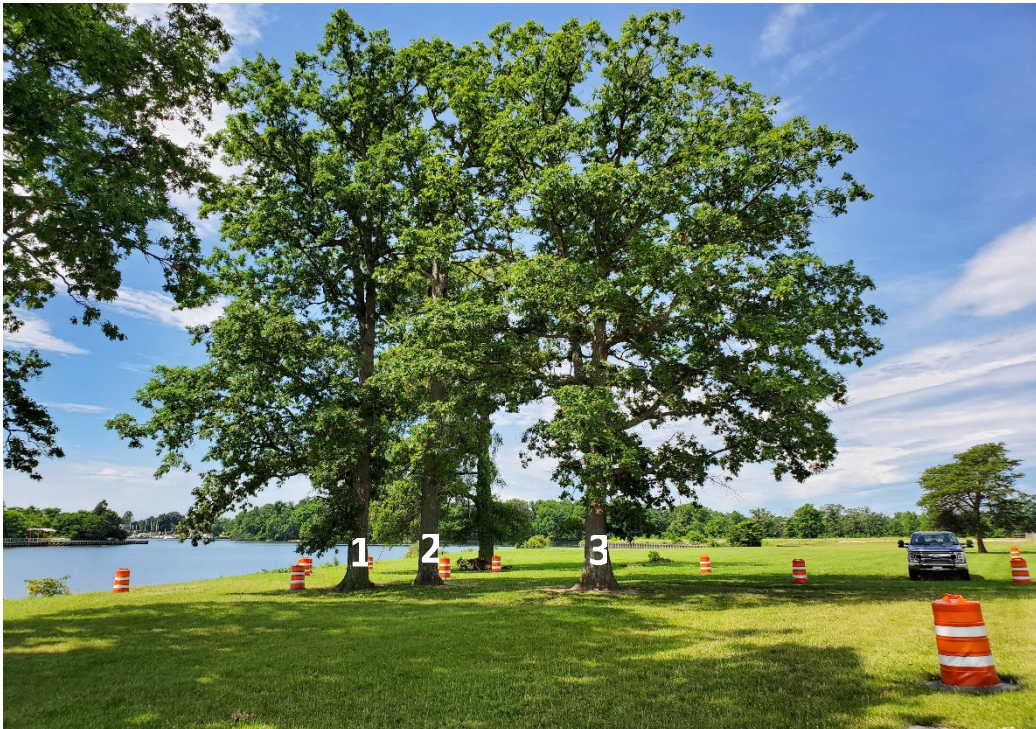
*Photo 9 View of three trees looking south (July 2022)*

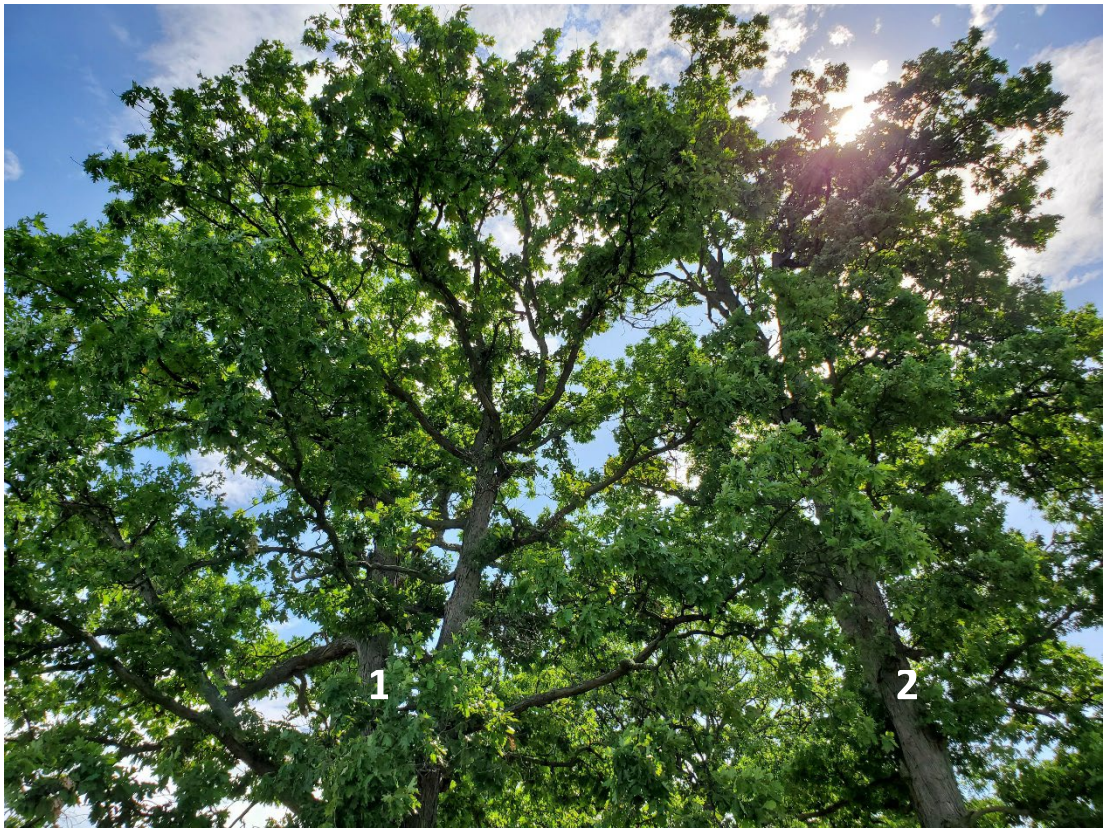
Photo 10 Tree canopies looking south (July 2022)

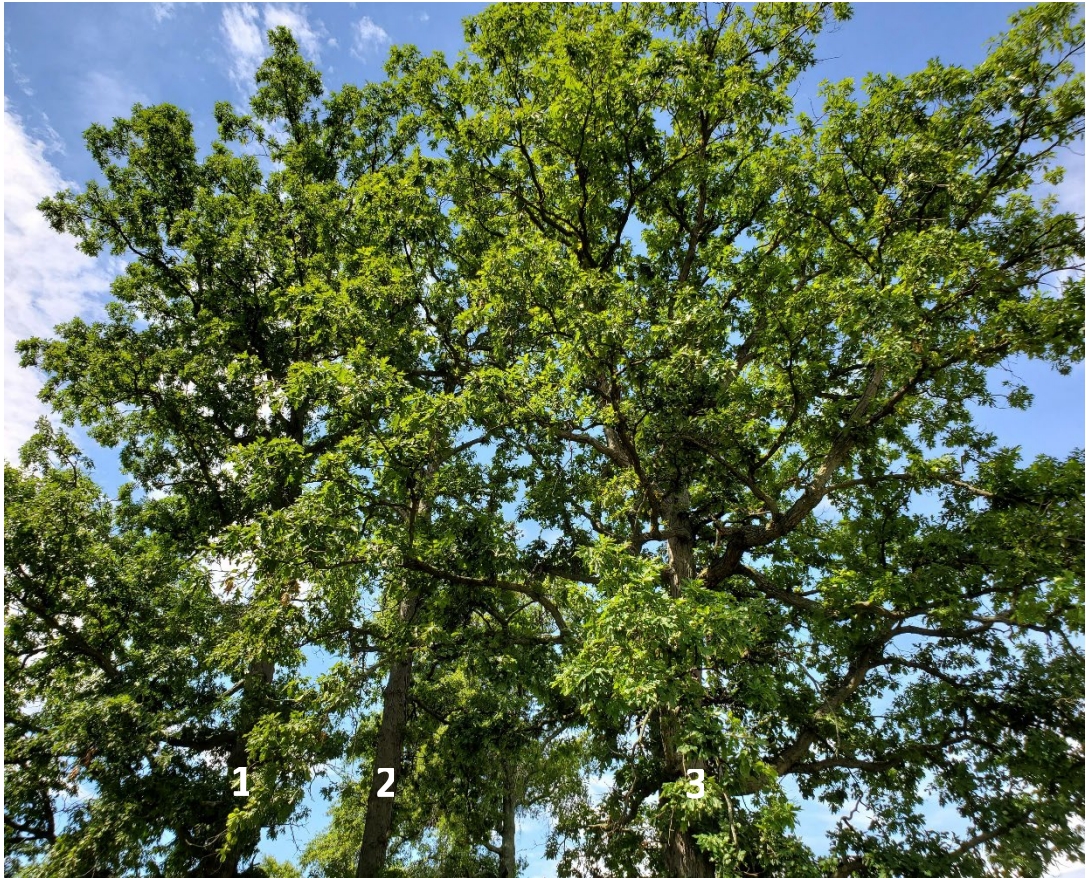
Photo 11 Tree canopies looking southeast July 2022

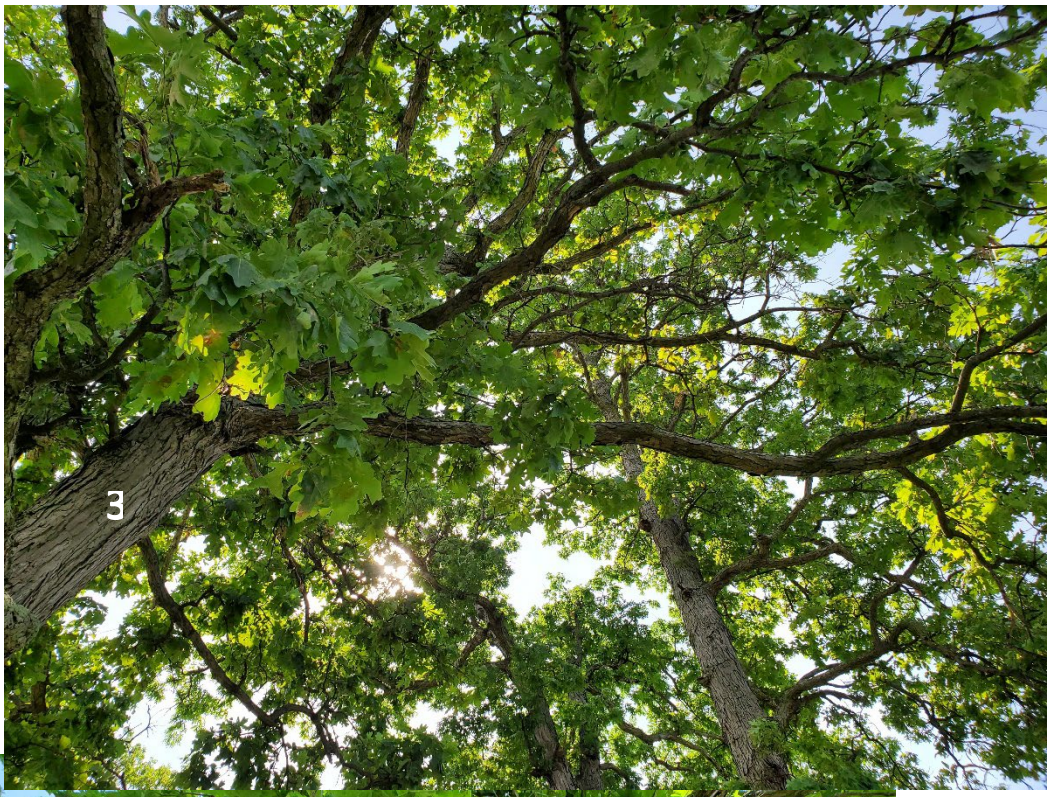
*Photo 12 Canopy on tree 3 (July 2022)*

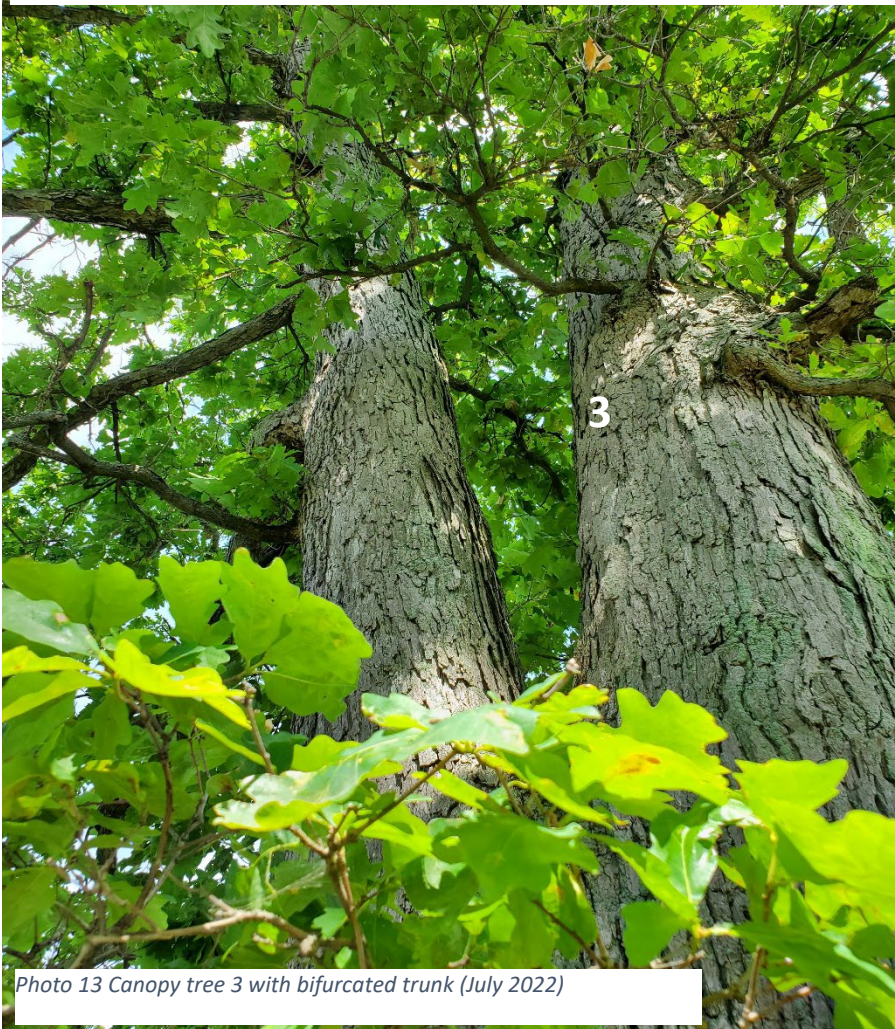
*Photo 13 Canopy tree 3 with bifurcated trunk (July 2022)*
